Diamant Replacement Canopy

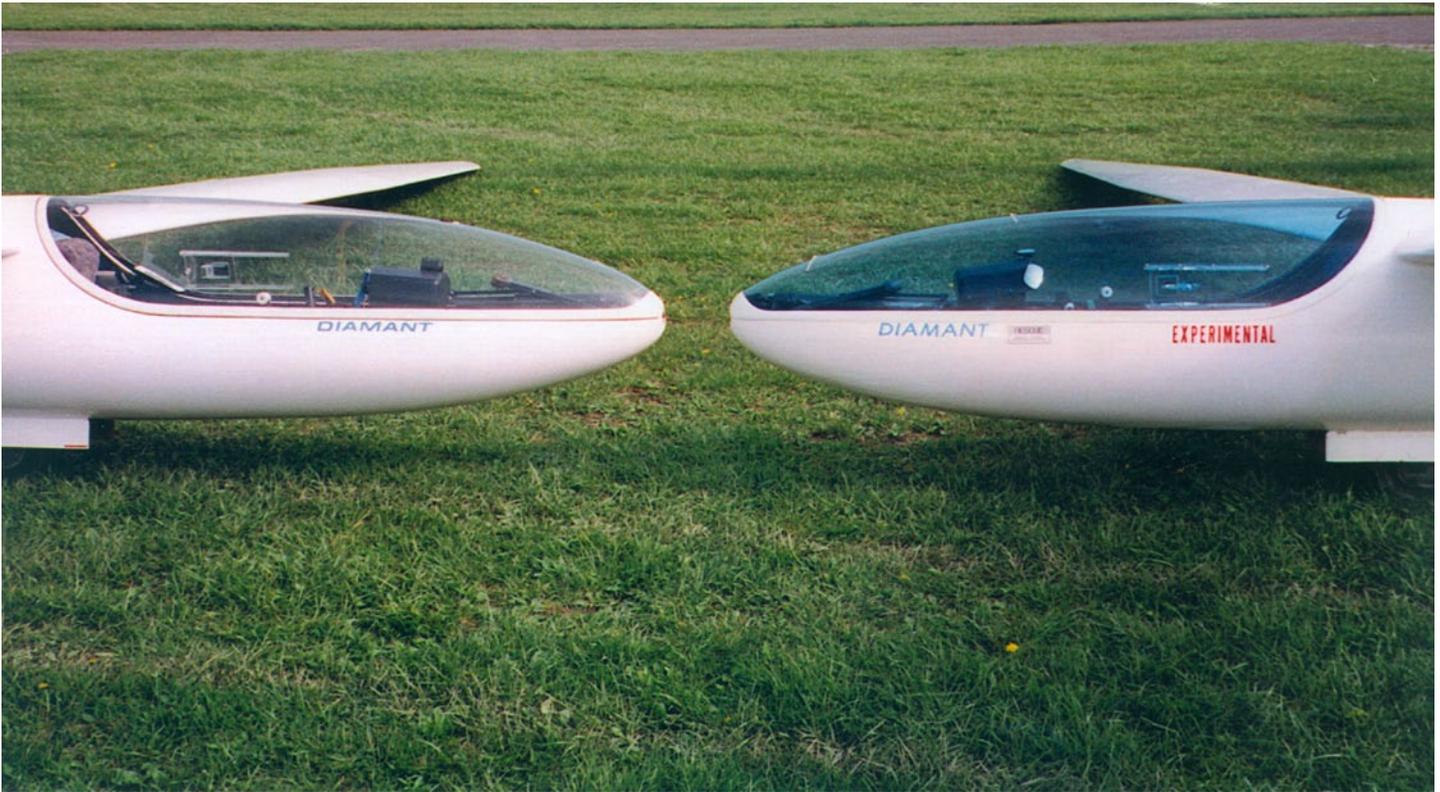
The left one is Pierre's original, the right Art's new one. I now learned Art's new canopy was formed on top of another original. This new canopy was blown by Ray Poquette and replaces the "Cowley Canopy" which was on the ship when Art acquired it.

Note the ship's original canopy was broken in a trailer accident when the trailer rolled over while being towed. The new canopy is blue tinted and has a UV protective filter. The mounting and fit

of this new canopy is quite nice and returns the ship's appearance to the original design.

According to Art, there are 100 brass screws which hold the canopy onto the canopy frame. Each hole had to be drilled to match the existing hole in the canopy frame then countersunk, and finally deburred. Additionally to mount the canopy on the frame a seal had to be made of foam insulation and then masked off, to prevent the epoxy from running down the interior of the canopy as it dried. There is also a sliding vent with a "blast door" on the left side of the canopy to provide additional cooling and ventilation to the cockpit area when the canopy is closed.
